PUBLIC UTILITIES REGULATORY COMMISSION (PURC)

**INVESTIGATION INTO THE CAUSES OF THE THREE
TOTAL SYSTEM COLLAPSES IN THE GHANA POWER
SYSTEM**

**DRAFT FINAL REPORT OF THE FACT FINDING
COMMITTEE**

30th April, 2012

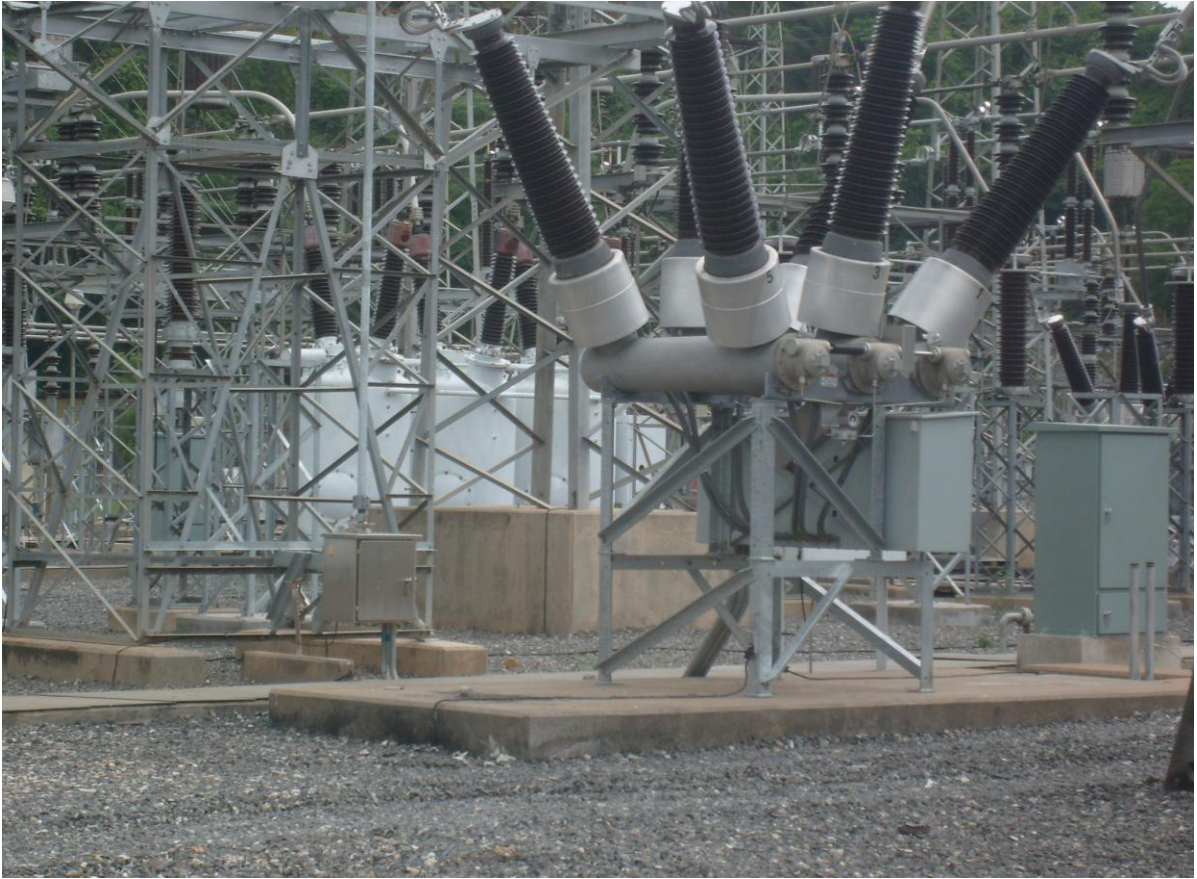
Picture of a section of the Akosombo Switchyard. Find attached Akosombo 161kV switchyard Single Line Diagram as Appendix 12.
