PUBLIC UTILITIES REGULATORY COMMISSION (PURC)

**INVESTIGATION INTO THE CAUSES OF THE THREE
TOTAL SYSTEM COLLAPSES IN THE GHANA POWER
SYSTEM**

**DRAFT FINAL REPORT OF THE FACT FINDING
COMMITTEE**

30th April, 2012

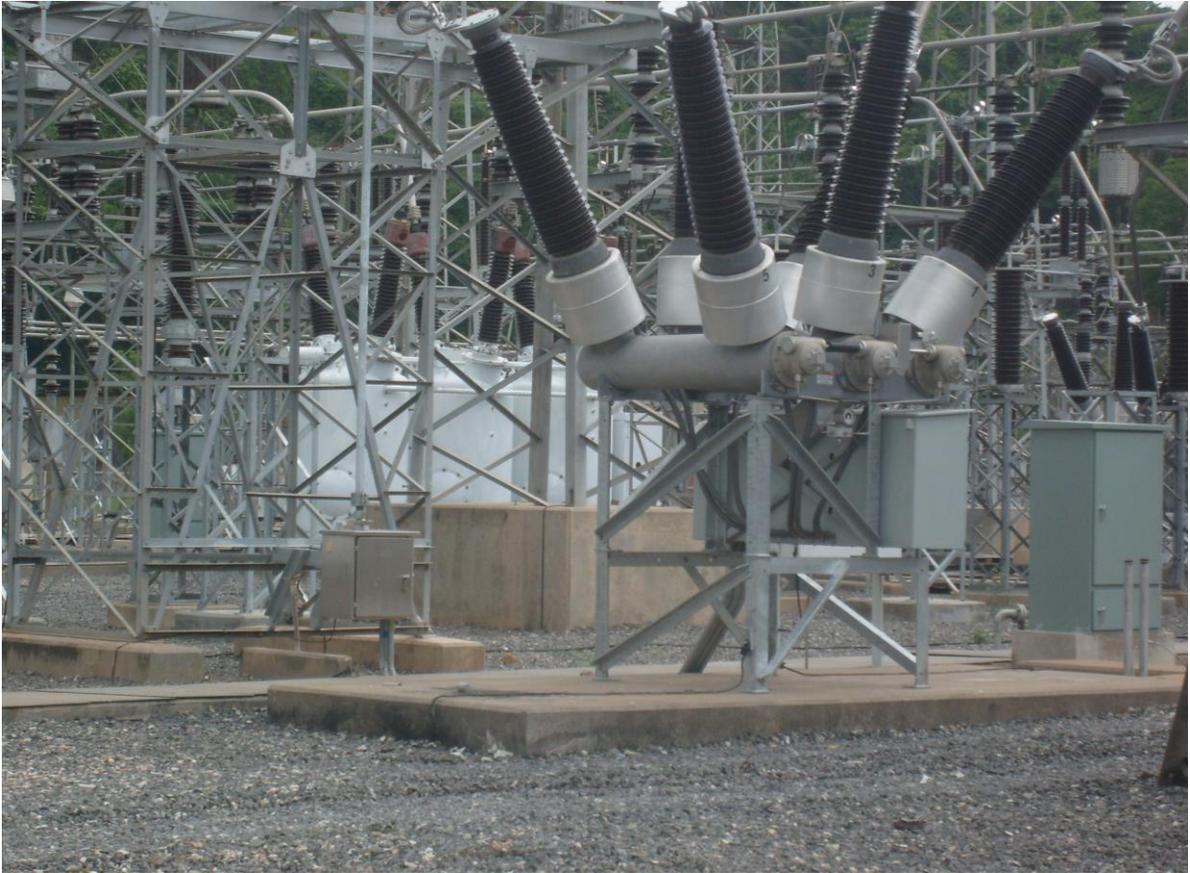
Picture of a section of the Akosombo Switchyard. Find attached Akosombo 161kV switchyard Single Line Diagram as Appendix 12.

The equipment at the Akosombo switchyard are functionally operative. However the Oil Circuit Breakers (OCB) have been giving problems because of their age (installed in 1976) and lack of spares for effective maintenance and are therefore in poor state . According to VRA reports, they were advised as far back as 2004 to replace the OCBs because the production of parts from the original equipment manufacturer have ceased.

As at the time of FFC's visit, the refurbishment of the switchyard which is being undertaken by WAPP with World Bank funding was in progress. About 30% of the OCBs have so far been replaced.
